# Ogden High Auditorium & Gym

# Seismic Risk Factors:

# Renovation Plan:

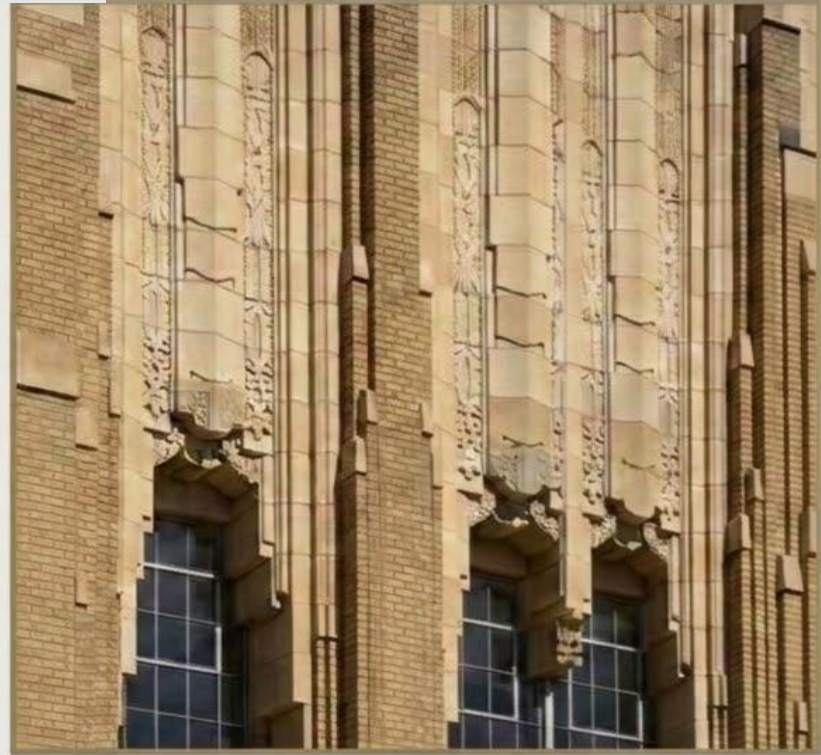
## Vulnerable Construction:

Unreinforced Masonry &  
Terracotta

Historically Poor Seismic  
Performance

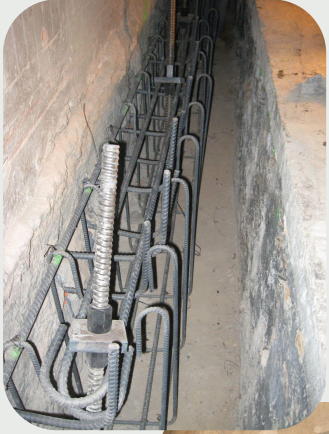
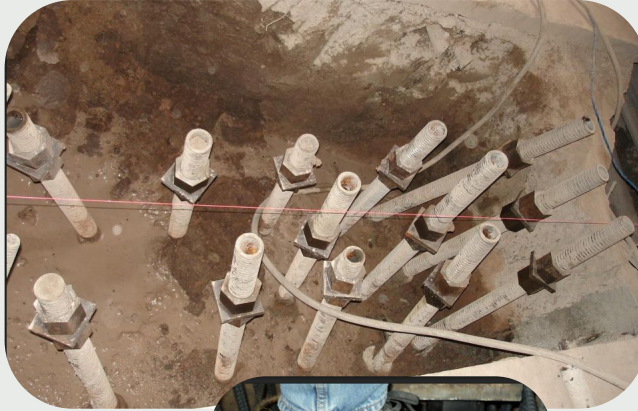
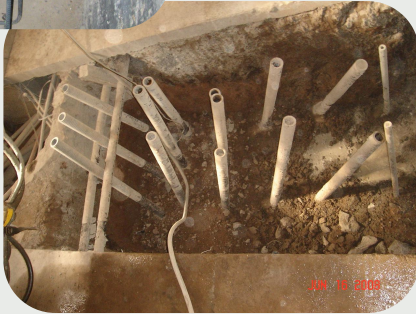
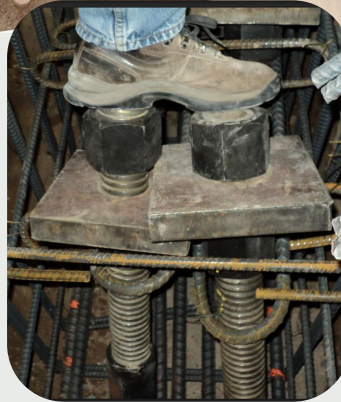
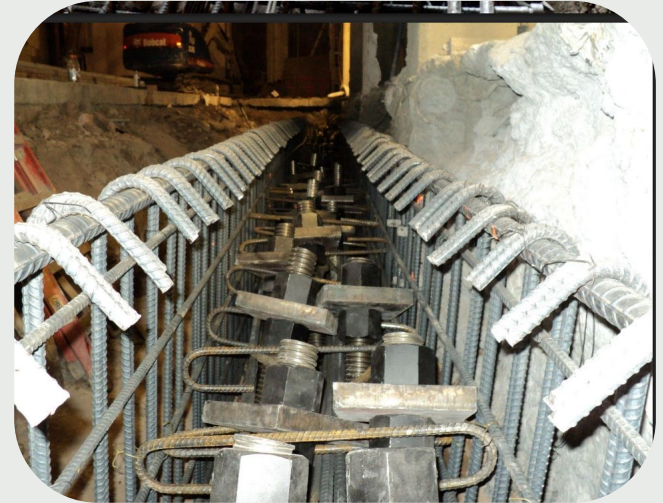
- New foundations

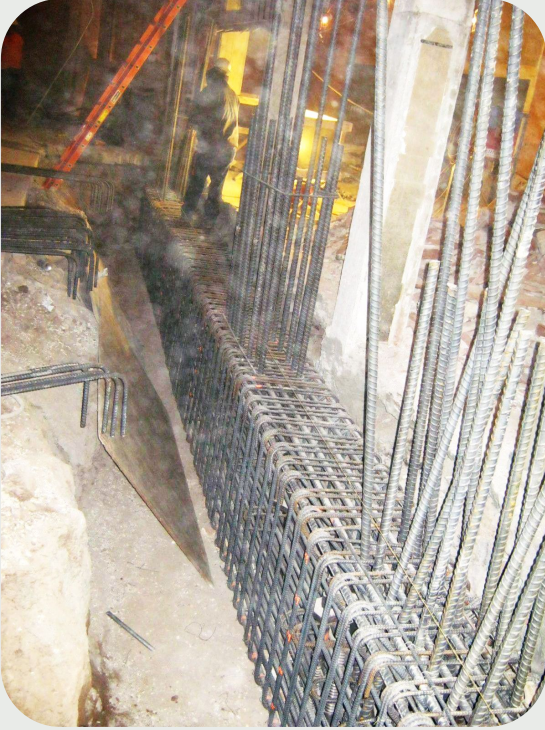
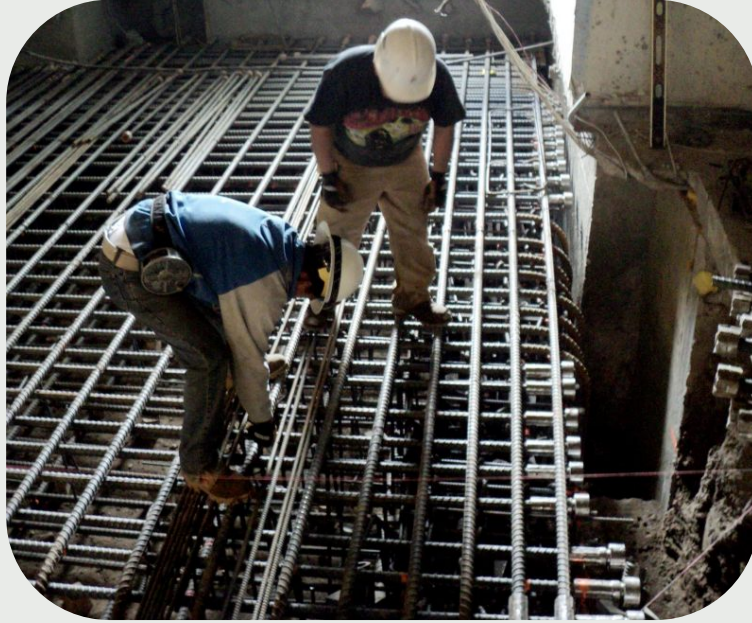
- New foundations

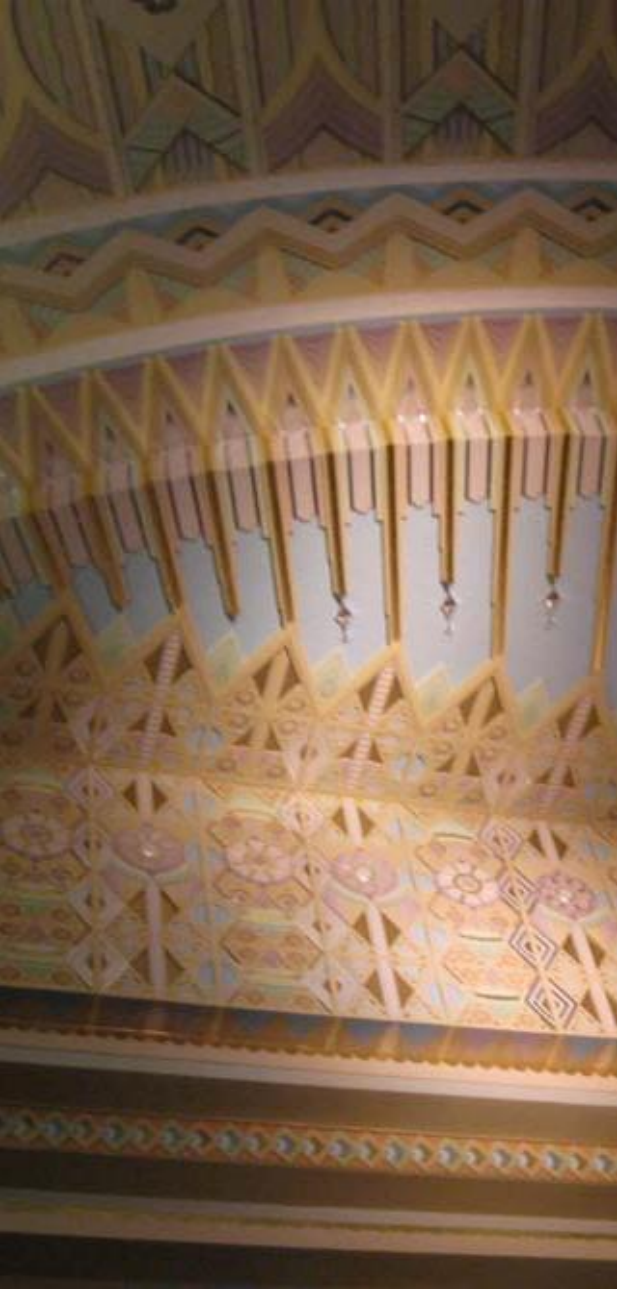
Phase 3

**Phase 3**  
 restoration and renovation of Buildings 1 and 2  
 new science center and performing arts center in Building 1  
 new applied technology laboratory  
 landscape enhancements
